Errata Sheet

SLG46533, SLG46534, SLG46535, SLG46536, SLG46537, SLG46538

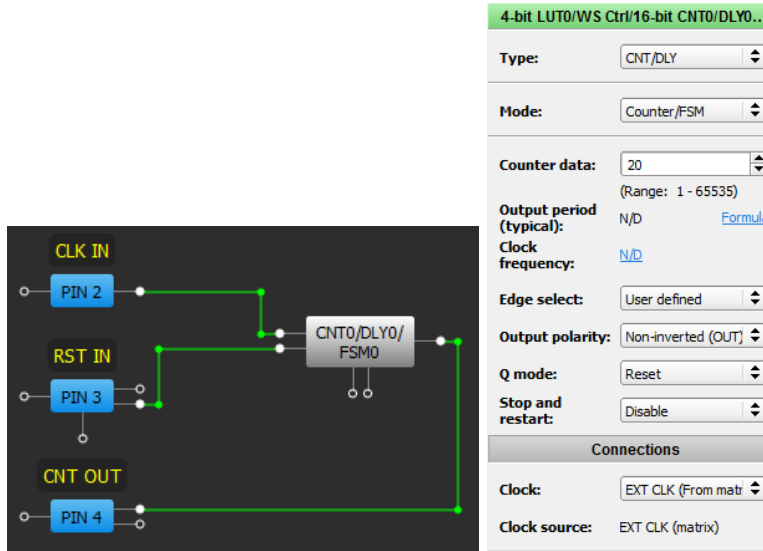
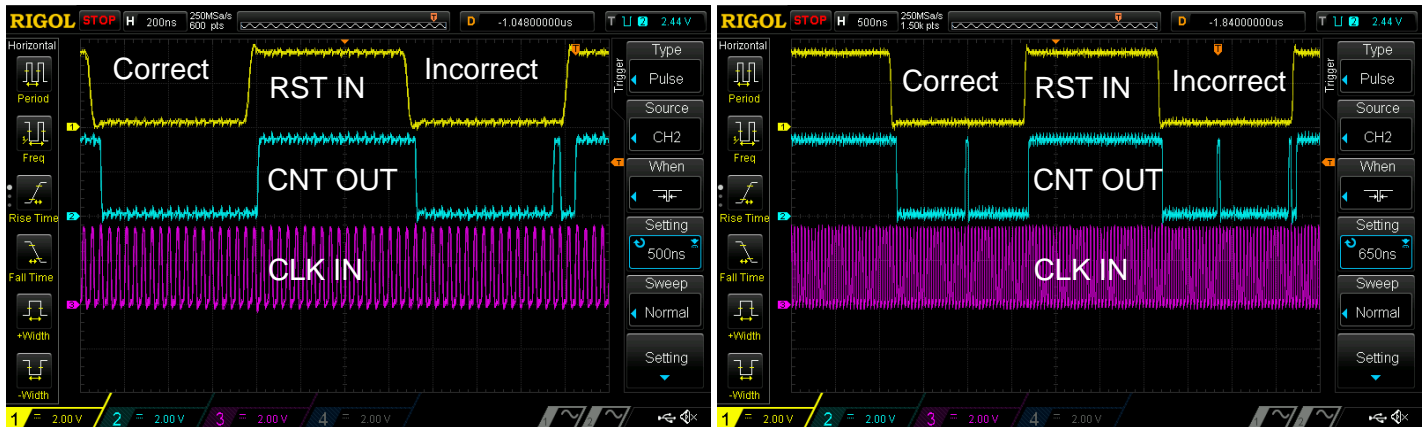
ISSUE 1: Counter Incorrect Operation after the Reset Functional Block Affected: Counter

If the Counter Reset is asserted at the same time as a rising clock edge, it is possible that the Counter Data will be reset incorrectly and the counter output may appear faster than expected. This phenomenon appears more often as the clock frequency increases.

- Synchronize RESET input of the Counter with its CLK using 2 DFF cells as shown on picture below.

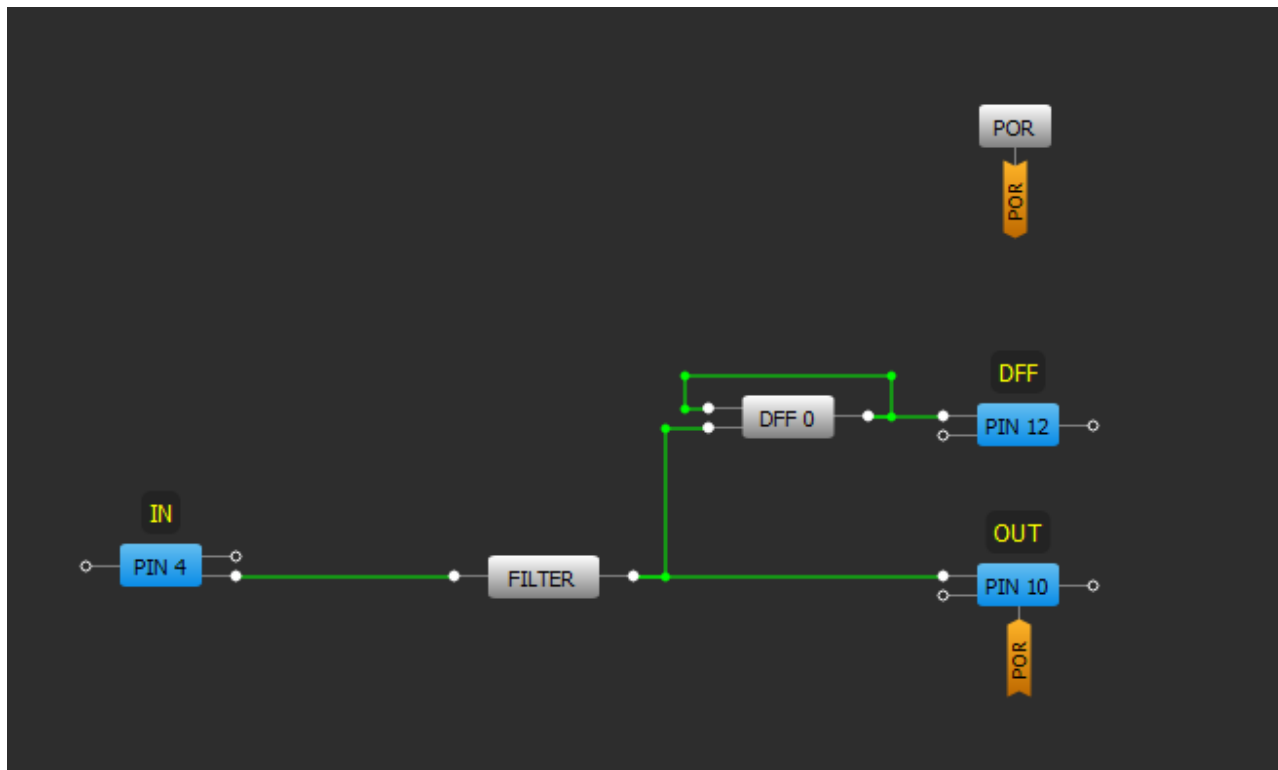
If clock type high frequency input comes in, the FILTER cell may not filter it out. There are several factors like input frequency, duty cycle and LOW duration in such signal that may lead to its passing through FILTER block.

Channel 1 (yellow/top line) – PIN#4 (IN)
Channel 2 (light blue/2nd line) – PIN#10 (OUT)
Channel 3 (magenta /3rd line) – PIN#12 (DFF)

Currently there is no workaround for this issue. Filter block is good at filtering short spontaneous glitches. It is intended to be used in series connection before the delay cell to avoid its latching (see issue #2).

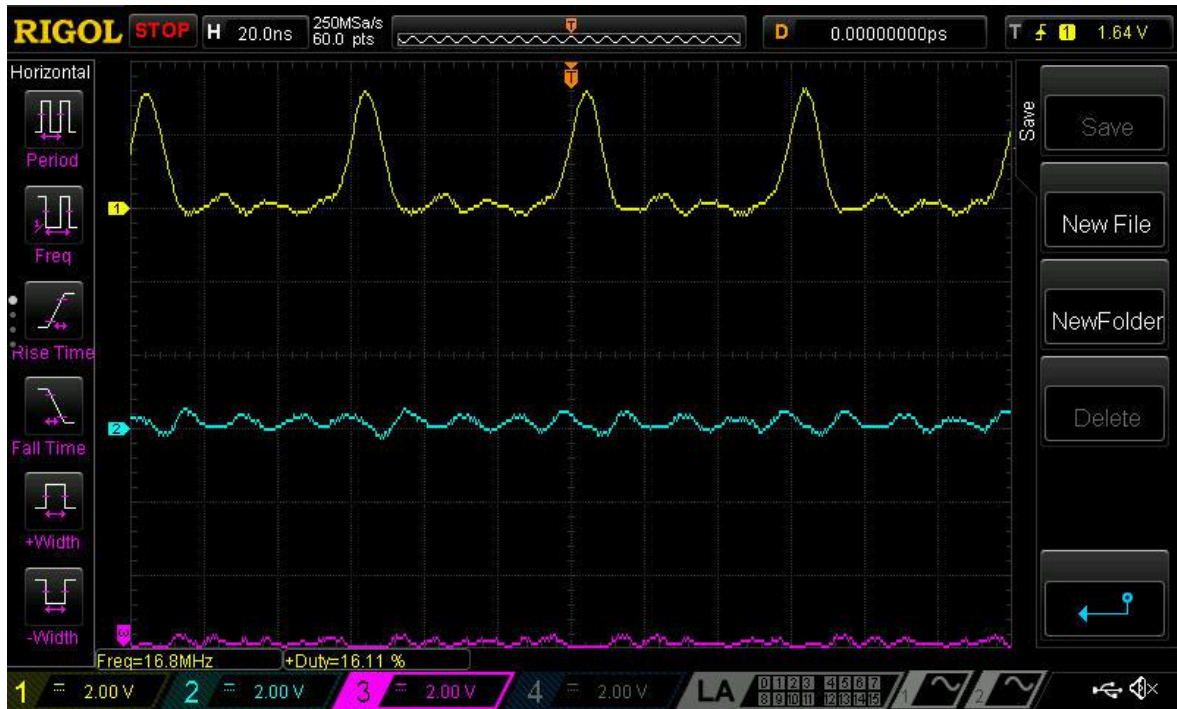
1. Period is 60ns. Pulse width is 10ns DC=16.7% (Correct functionality)

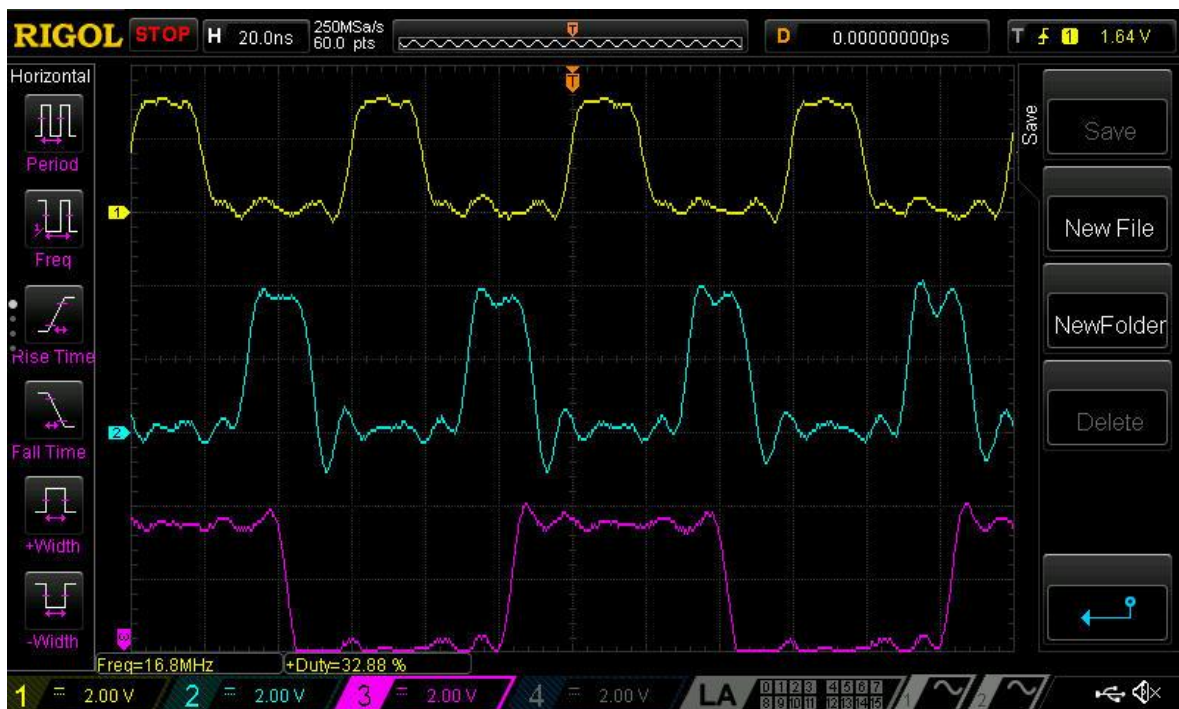
2. Period is 60ns. Pulse width is 20ns DC = 33.3% (Incorrect functionality)

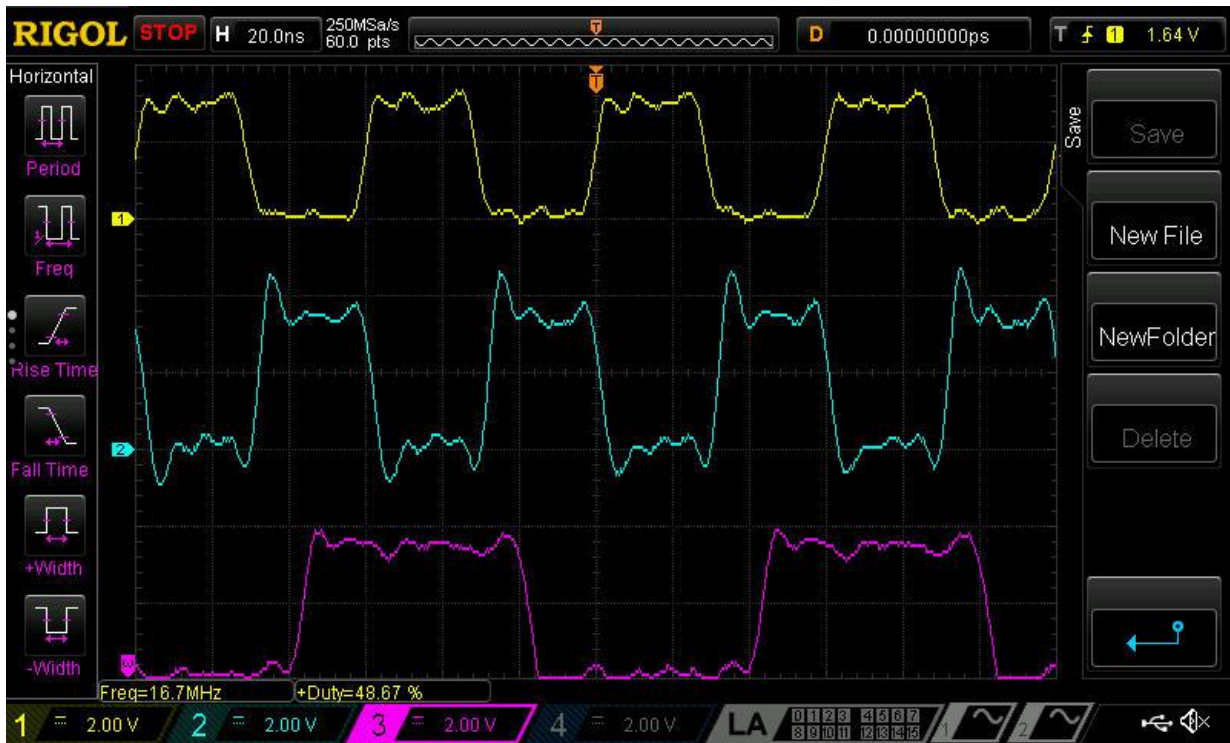
3. Period is 60ns. Pulse width is 30ns DC=50% (Incorrect functionality)

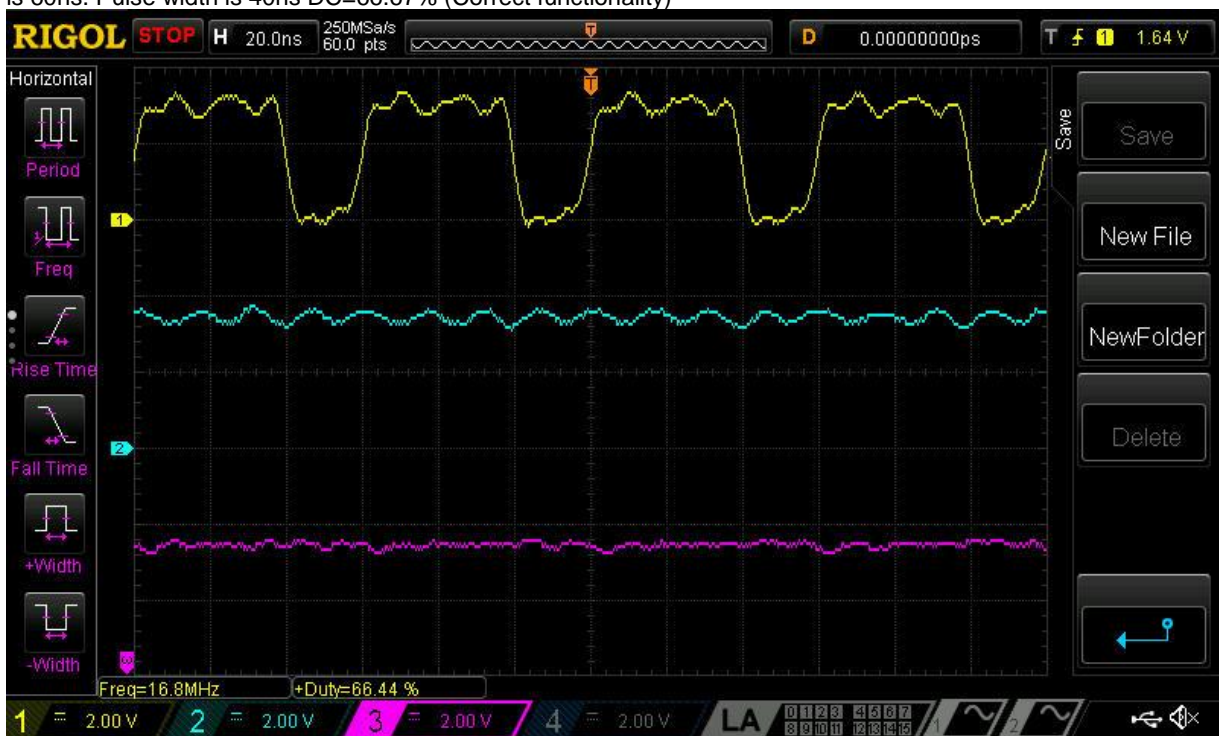
4. Period is 60ns. Pulse width is 40ns DC=66.67% (Correct functionality)

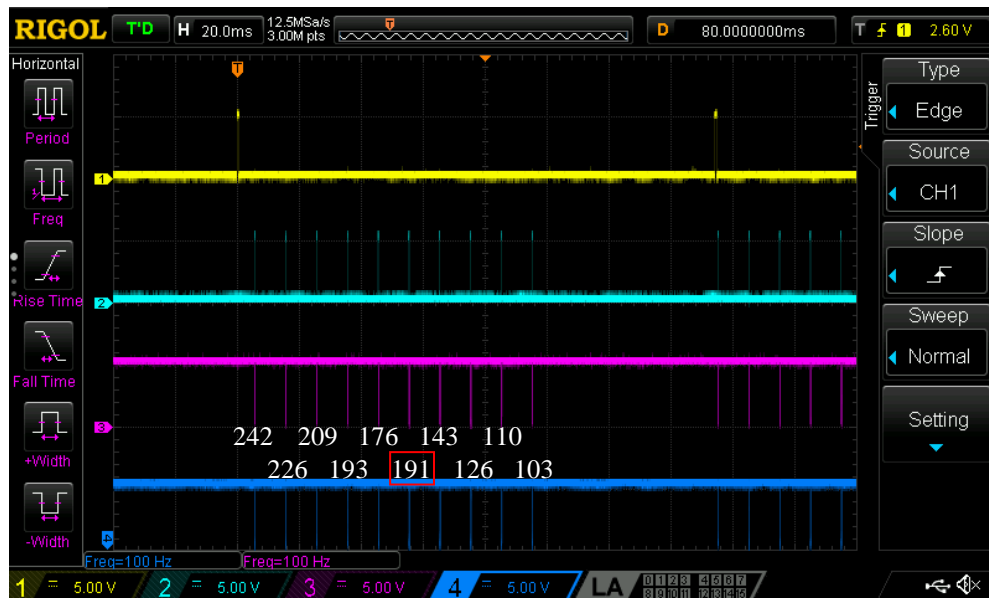
Asynchronous interaction between the CNT/DLY clock input and the I²C latch signal (generated by an I²C read command of the CNT/DLY block's count value) can result in an incorrect I²C data read. The CNT/DLY block will count accurately, but the count value transferred into the block's I²C read register might be loaded incompletely if the I²C latch signal and the clock input occur at about the same time.

The example data capture below shows ten periodic I²C reads of CNT2/DLY2 configured to count down at about 16 clocks per read. The sixth read sample erroneously shows a value greater than that of the fifth. The seventh sample reads as if the previous I²C error never occurred - the difference from the fifth sample (176) to the seventh (143) is 33 clocks or 16 clocks + 17 clocks as expected.

- Channel 1 (yellow/top line) – PIN#2 (CNT2/DLY2 Out)
- Channel 2 (light blue/2nd line) – PIN#1 (I²C Read Triggers)
- Channel 3 (magenta /3rd line) – PIN#8 (I²C SCL)
- Channel 3 (dark blue /4th line) – PIN#9 (I²C SDA)

If the possibility of incorrect I²C data reads can't be accommodated for by external software checks, one can guarantee proper operation by stopping the CNT/DLY block's clock during I²C reads through one of the following methods: by disabling the oscillator block, by reconfiguring the CNT/DLY block's clock source, or by gating an external clock using a LUT (Look-up Table) in the signal matrix. After disabling the CNT/DLY block's clock, the count registers can be read without error. Please note that this workaround will add the I²C read and processing time to the counter's overall clock period.

The best workaround depends on the resource constraints of the application. If the oscillator block doesn't clock other logic elements within the design, a matrix output can be used to manually power down the oscillators for the I²C read. When the CNT/DLY block's clock source is routed internally from the oscillator block, I²C commands can temporarily reconfigure the CNT/DLY block's clock

source registers to select “Ext. CLK. (From Matrix).” This action will disable the clock by connecting it to ground. If the CNT/DLY block is clocked from the signal matrix, a LUT can be used to gate the clock during an I²C read.
